**STRUCTURAL INSPECTION REPORT**

**August 9th, 2021**

**250 174<sup>TH</sup> St  
SUNNY ISLES FL. 33160**

**PREPARED BY  
GANEM CONSULTING ENGINEERING  
ALIOSKAR GANEM PE.  
LIC. 74745**

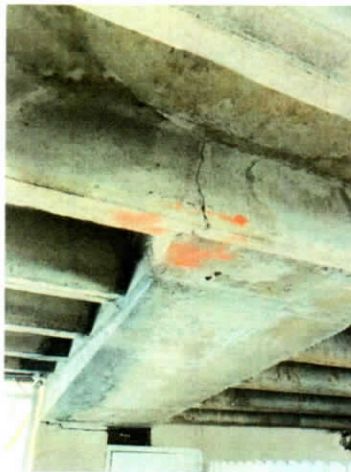
#### RP#1

**Location:** Concrete Joist East Ramp  
**Type of Repair:** Spalled concrete  
**Status:** Spalled Concrete  
**Inspection Date:** 08-09-2021

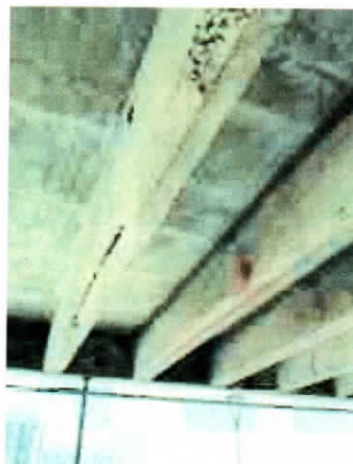
#### RP#2

**Location:** Concrete Joist (Spot 239)  
**Type of Repair:** Spalled concrete and honeycomb  
**Status:** Spalled Concrete  
**Inspection Date:** 08-09-2021

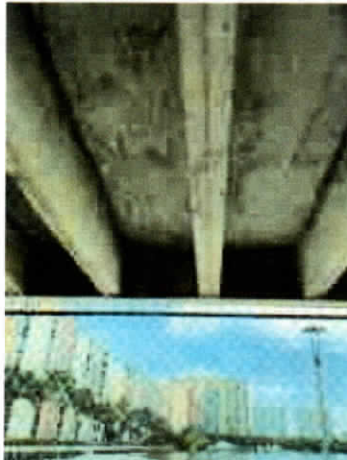
**Type of Repair:** Edge repair

**Status:** Spalled Concrete

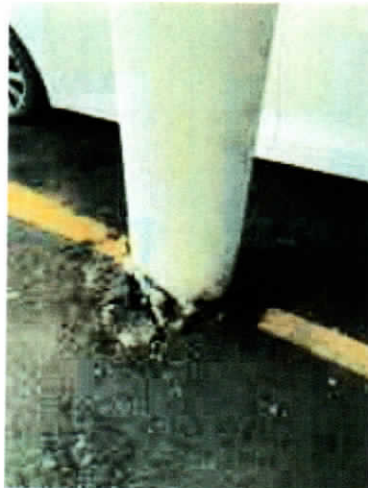
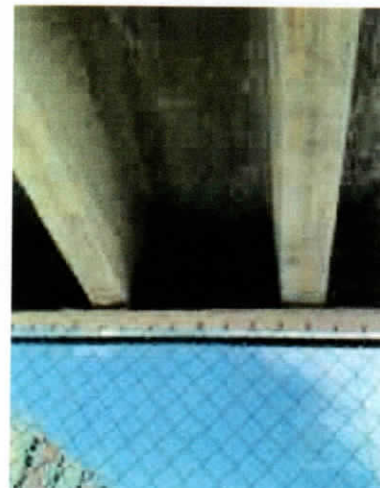
**RP#4**

**Location:** 234

**Type of Repair:** Spalled concrete edge repair, rebar exposure at the bottom

**Status:** Spalled Concrete

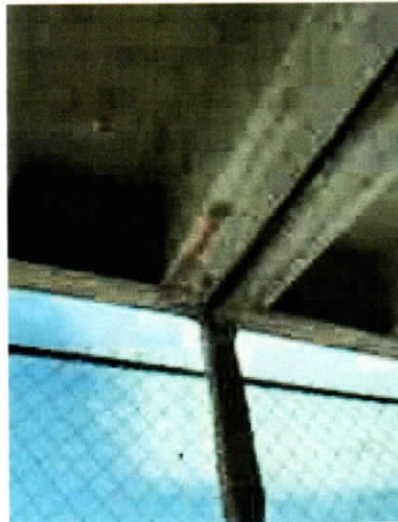
**Type of Reparation:** Spalled Concrete

**Status:** Spalled Concrete

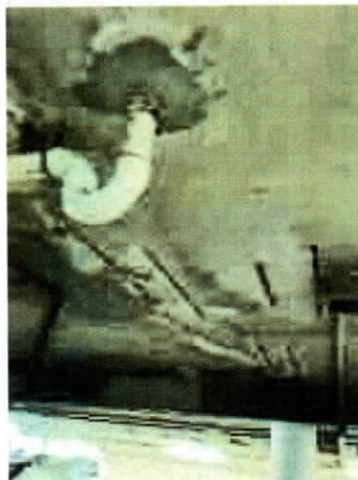
**RP#6**

**Location:** 2<sup>nd</sup> level Slab below toilets (spots 302-306)

**Type of Reparation:** Spalled Concrete

**Status:** Spalled Concrete

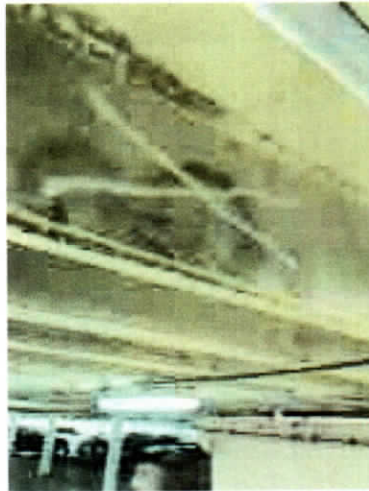
**Type of Repair:** Hairline Crack

**Status:** Spalled Concrete

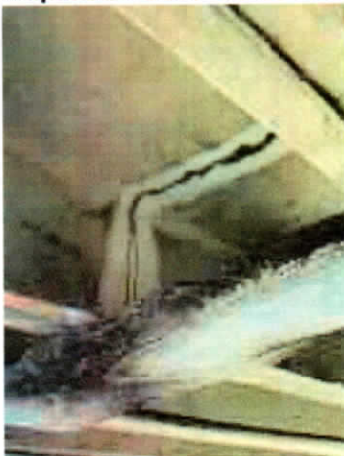
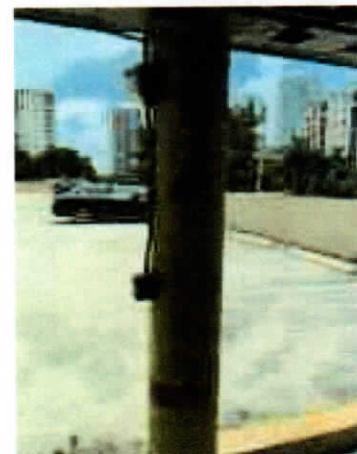
**RP#8**

**Location:** Slab above 255

**Type of Repair:** Full Concrete repair and column

**Status:** Spalled Concrete

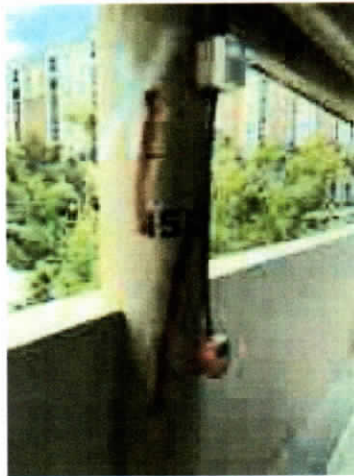
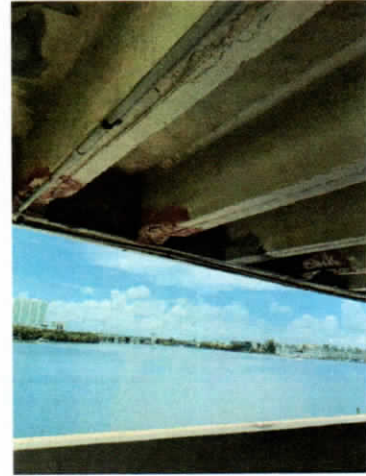
**Type of Repair:** Spalled concrete

**Status:** Spalled Concrete

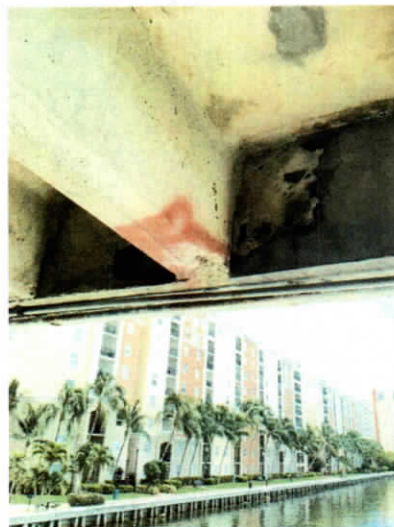
**RP#10**

**Location:** Concrete Joist above parking # 455

**Type of Repair:** Spalled Concrete

**Status:** Spalled Concrete

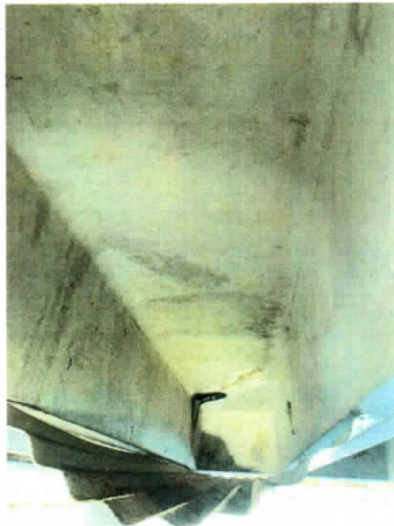
**Type of Repair:** Full Concrete

**Status:** Spalled Concrete

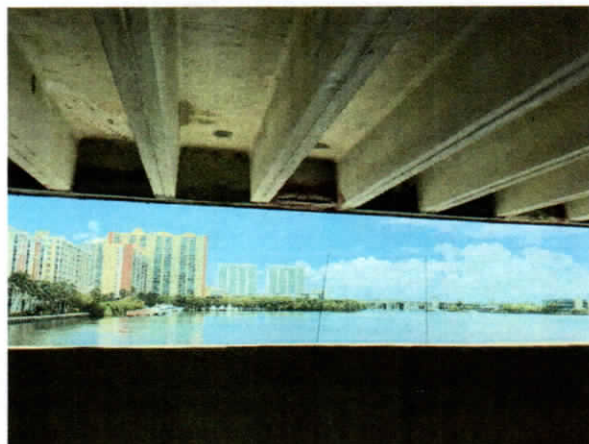
**RP#12**

**Location:** edge at parking # 442 and 446

**Type of Repair:** Edge Repair

**Status:** Spalled Concrete

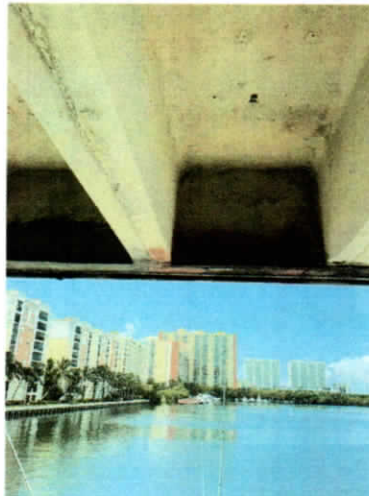
**Type of Repair:** Spalled concrete on Joist and edge Repair

**Status:** Spalled Concrete

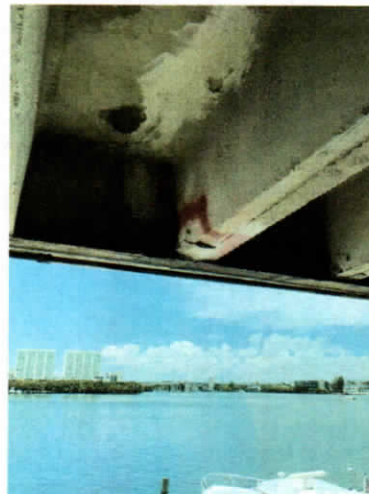
**RP#14**

**Location:** slab above parking #438

**Type of Repair:** Spalled concrete on joist and edge

**Status:** Spalled Concrete

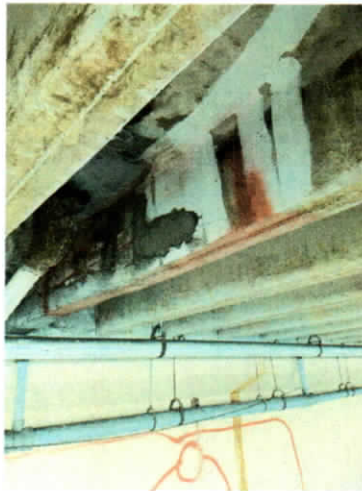
**Type of Repair:** Joist Repair

**Status:** Spalled Concrete

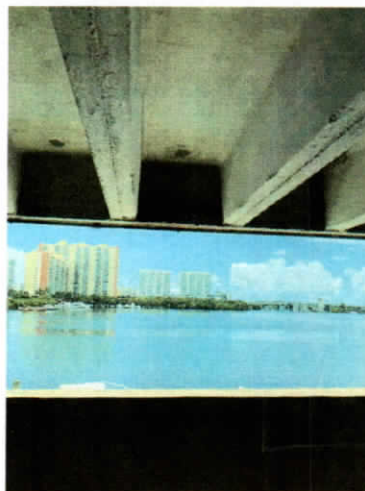
**RP#17**

**Location:** slab edge at parking #434

**Type of Repair:** Edge Repair

**Status:** Spalled Concrete

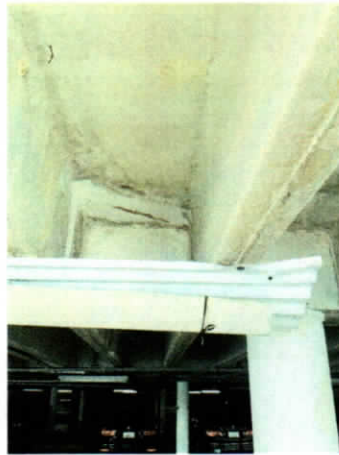
**Type of Reparation:** Full Concrete Repair

**Status:** Spalled Concrete

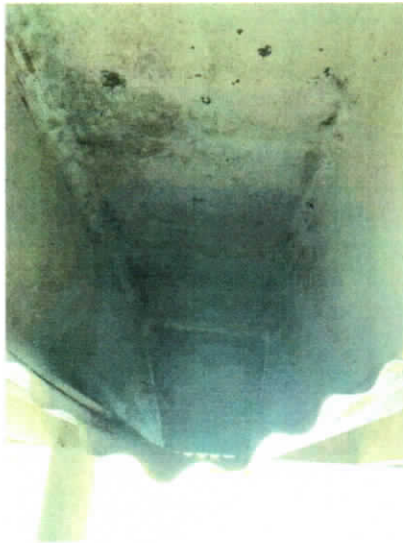
**RP#19**

**Location:** Slab above parking #431

**Status:** Spalled Concrete

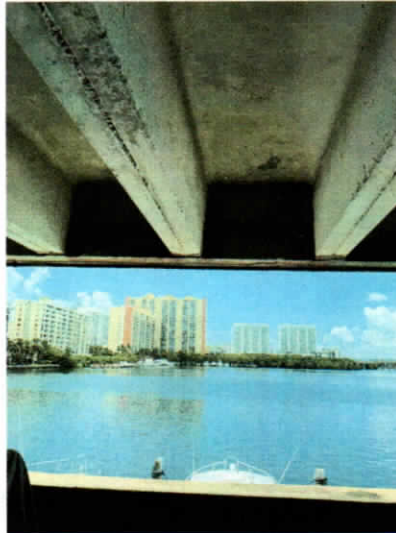
**Type of Reparation:** Edge Repair

**Status:** Spalled Concrete

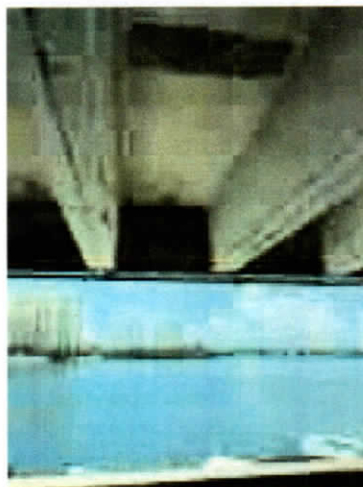
**RP#21**

**Location:** Edge parking #427

**Type of Reparation:** Edge Repair

**Status:** Spalled Concrete

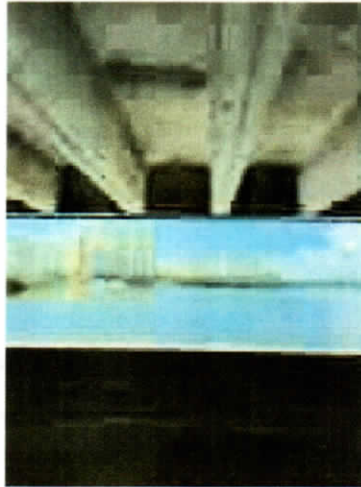
**RP#22**

**Location:** Edge parking #424  
**Type of Repair:** Edge Repair  
**Status:** Spalled Concrete  
**Inspection Date:** 08-09-2021

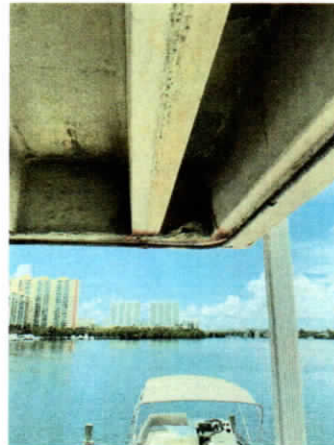
**RP#23**

**Location:** Edge at parking # 420  
**Type of Repair:** Edge Repair  
**Status:** Spalled Concrete  
**Inspection Date:** 08-09-2021

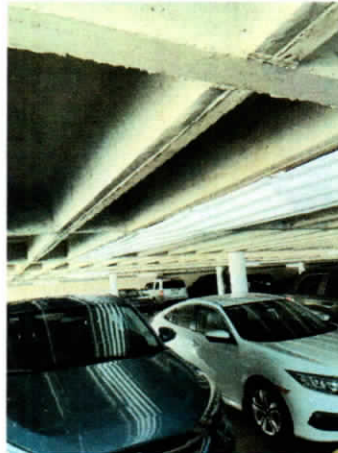
**Type of Reparation:** Slab repair

**Status:** Spalled Concrete

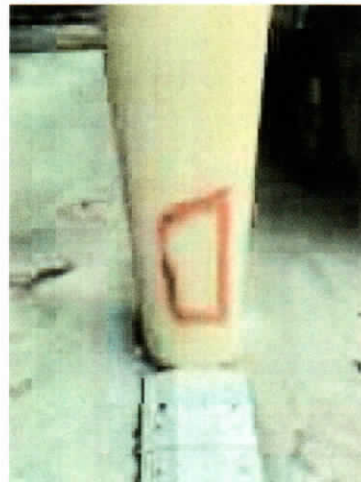
**RP#25**

**Location:** Column parking # 359

**Type of Reparation:** Column Repair

**Status:** Spalled Concrete

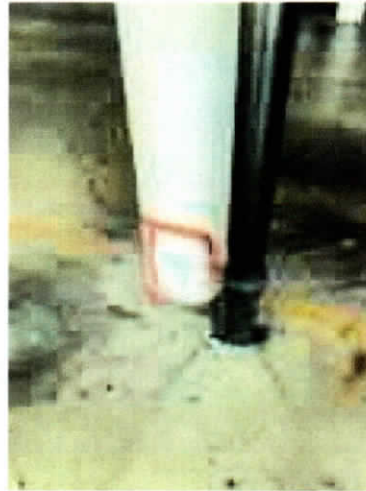
**Type of Repair:** Column Repair

**Status:** Spalled Concrete

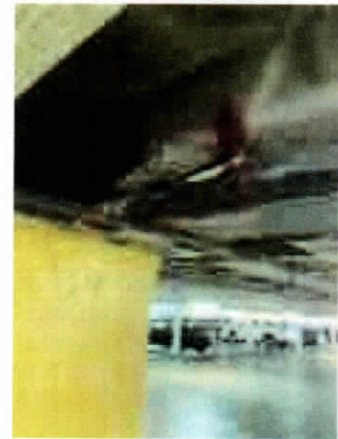
**RP#27**

**Location:** 2<sup>nd</sup> Floor Slab parking # 319 - 318

**Type of Repair:** Joint Repair

**Status:** Spalled Concrete y expansion joint to be replaced

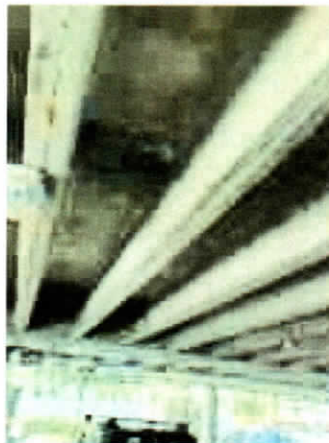
**Type of Repair:** Spalled concrete

**Status:** Spalled Concrete

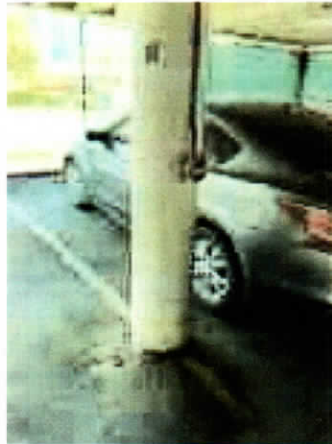
**Type of Reparation:** Spalled concrete on column

**Status:** Spalled Concrete

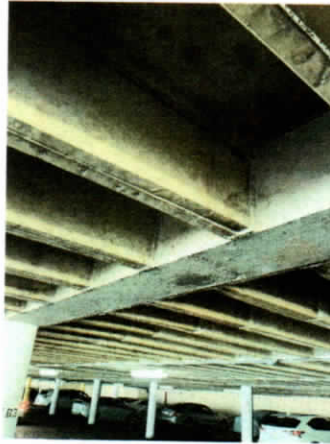
**Type of Repair:** Exposed rebar

**Status:** Spalled Concrete

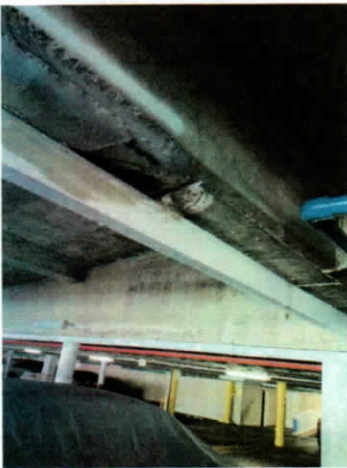
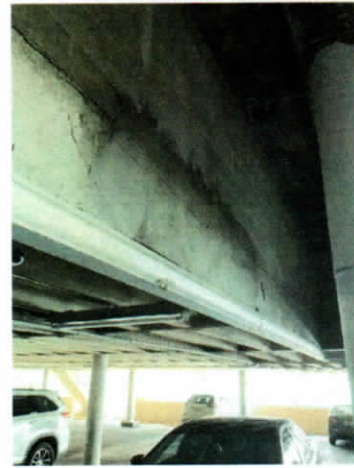
**Type of Reparation:** Spalled concrete

**Status:** Spalled Concrete

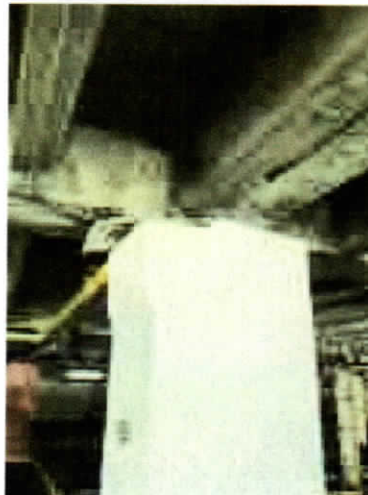
**Type of Reparation:** Spalled concrete and joint repair

**Status:** Spalled Concrete

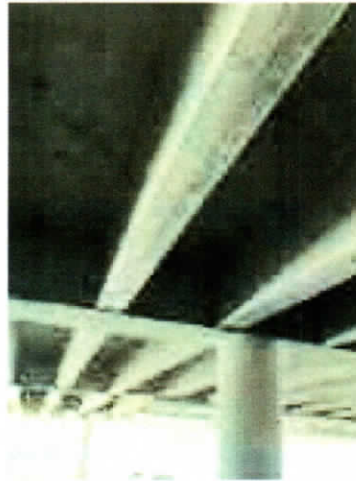
**Type of Repair:** Crack repair

**Status:** Spalled Concrete

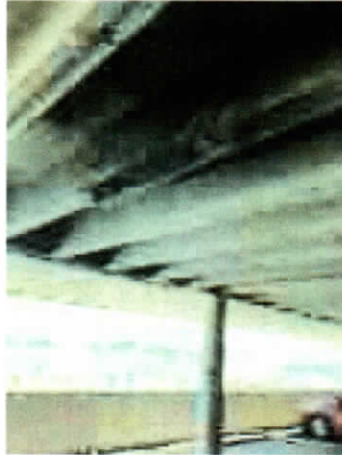
**Type of Repair:** Honeycombs

**Status:** Spalled Concrete

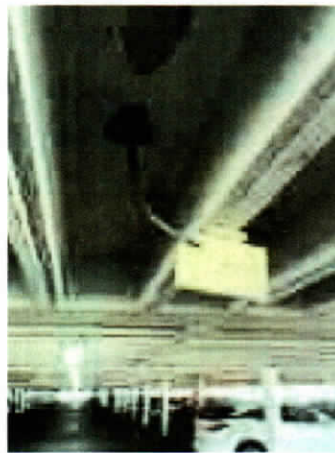
**Type of Reparation:** Spalled concrete

**Status:** Spalled Concrete

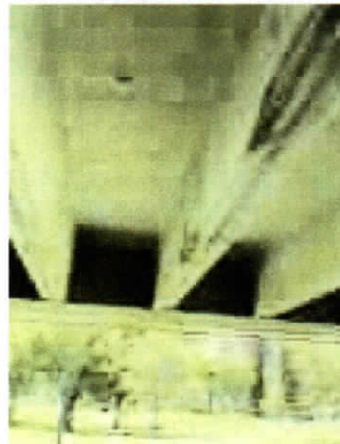
**RP#61**

**Location:** Ground Floor parking # 115

**Type of Reparation:** Spalled concrete

**Status:** Spalled Concrete

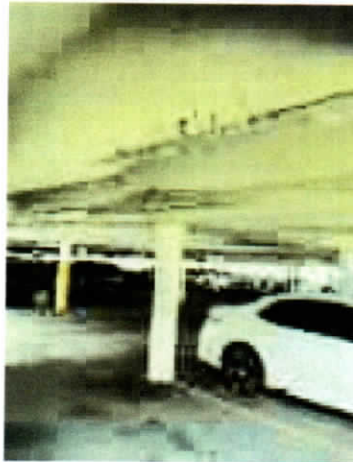
**Type of Repair:** Honeycombs with rebar exposure

**Status:** Spalled Concrete

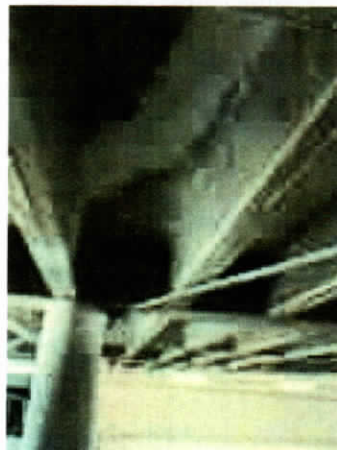
**Type of Reparation:** Crack repair

**Status:** Spalled Concrete

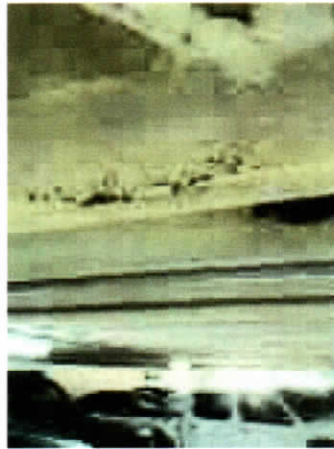
**Status:** Spalled Concrete

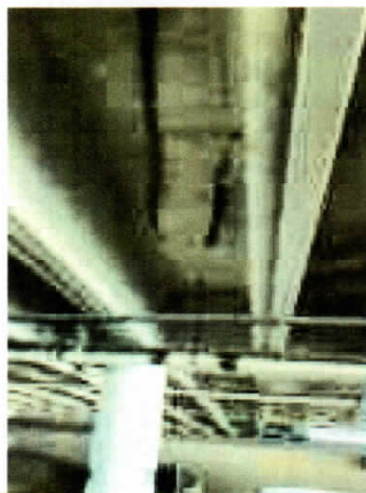
**RP#71**

**Location:** 2<sup>nd</sup> Floor parking # 285-286

**Type of Reparation:** Crack repair

**Status:** Spalled Concrete

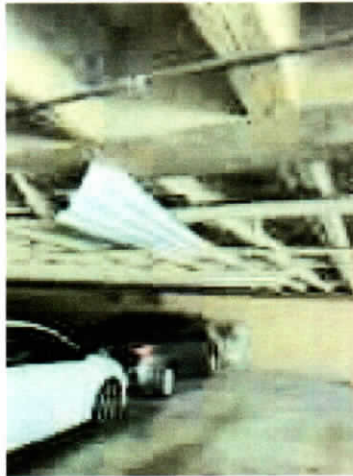
**Type of Reparation:** Full slab repair

**Status:** Spalled Concrete

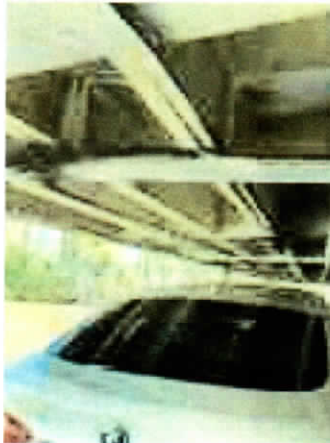
**Type of Reparation:** Full Crack repair

**Status:** Spalled Concrete

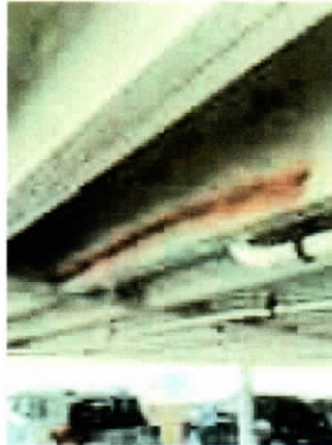
**Type of Reparation:** Crack repair on joist

**Status:** Spalled Concrete

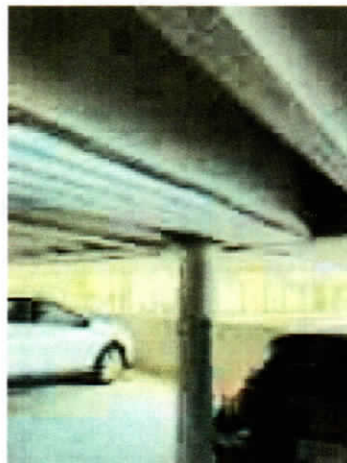
**RP#77**

**Location:** 2<sup>nd</sup> Floor parking # 450

**Type of Reparation:** Slab Repair

**Status:** Spalled Concrete

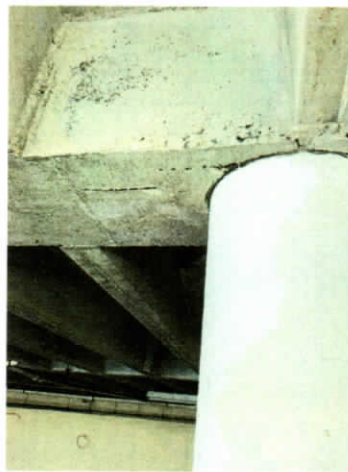
**Status:** Spalled Concrete

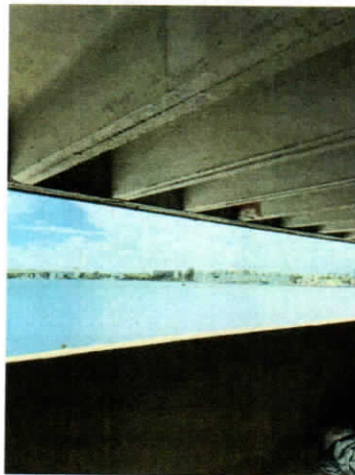
**Type of Repair:** Spalled concrete

**Status:** Spalled Concrete

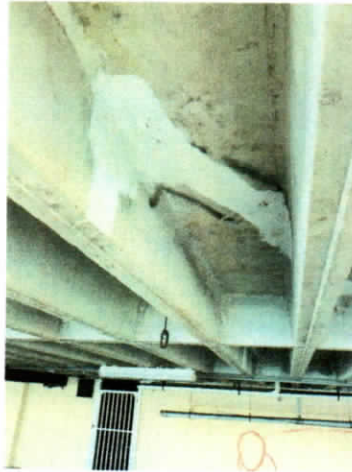
**Type of Repair:** Crack repair

**Status:** Spalled Concrete

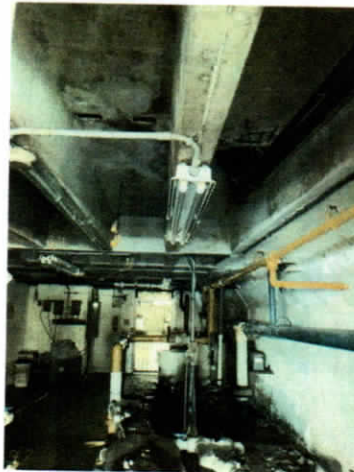
**RP#83**

**Location:** 2<sup>nd</sup> Floor Driveway front pool equipment room

**Type of Repair:** Spalled concrete, rebar exposure

**Status:** Spalled Concrete

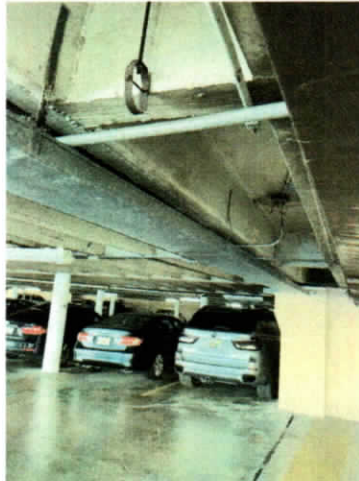
**Type of Repair:** Joint Repair

**Status:** Spalled Concrete

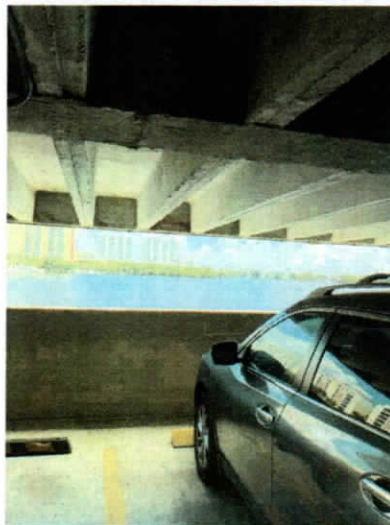
**RP#85**

**Location:** 2<sup>nd</sup> Floor parking # 435 434

**Type of Repair:** Edge repair

**Status:** Spalled Concrete

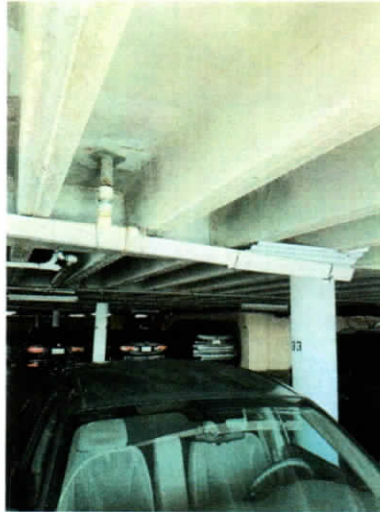
**Type of Reparation:** Crack repair on joist

**Status:** Spalled Concrete

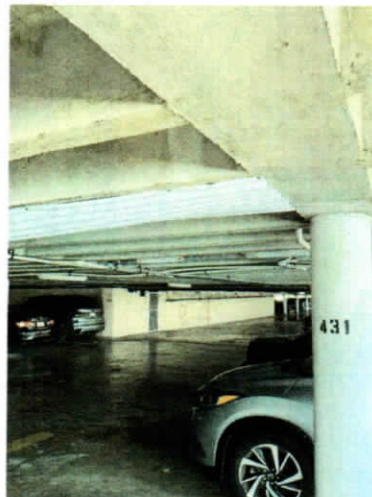
**RP#87**

**Location:** 2<sup>nd</sup> Floor parking # 431

**Type of Reparation:** Leaking crack repair

**Status:** Spalled Concrete

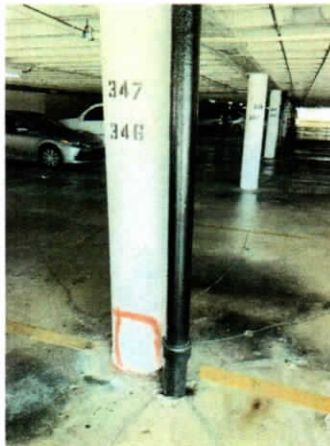
**Type of Repair:** Column repair

**Status:** Spalled Concrete

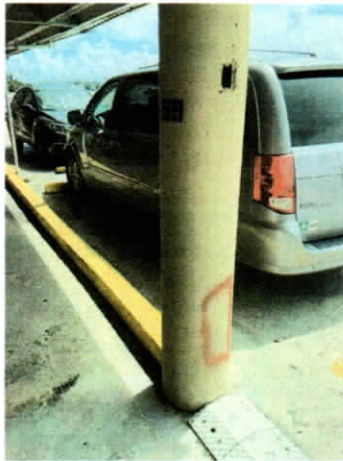
**Type of Repair:** Column repair

**Status:** Spalled Concrete

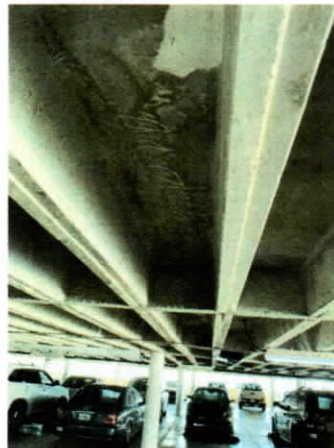
**RP#93**

**Location:** 2<sup>nd</sup> Floor driveway parking # 339 338

**Type of Repair:** Crack repair

**Status:** Spalled Concrete

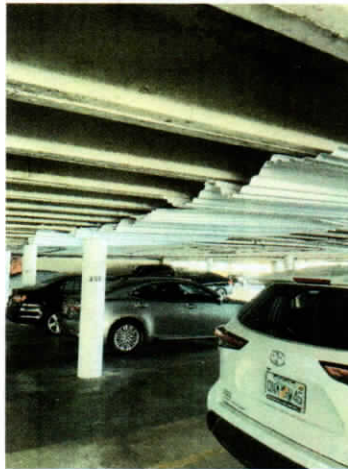
**Type of Reparation:** Leaking cracks repair

**Status:** Spalled Concrete

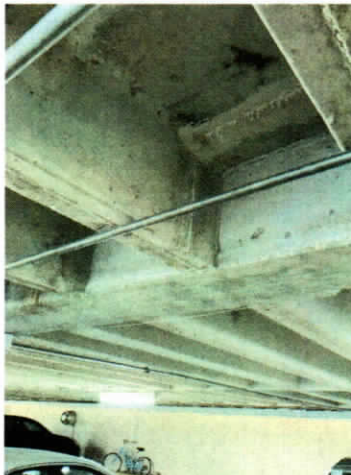
**RP#95**

**Location:** 2<sup>nd</sup> Floor parking # 325 324

**Type of Reparation:** Crack repair

**Status:** Spalled Concrete

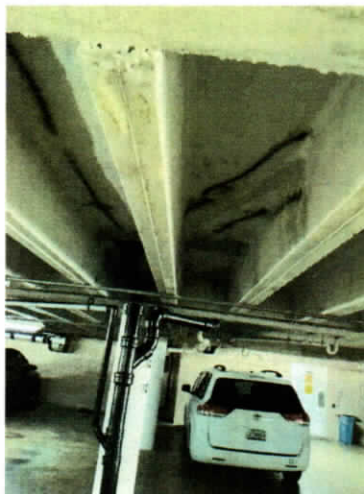
**Type of Reparation:** Cracks repair

**Status:** Spalled Concrete
