**STRUCTURAL INSPECTION REPORT**

**August 9th, 2021**

**250 174<sup>TH</sup> St  
SUNNY ISLES FL. 33160**

**PREPARED BY  
GANEM CONSULTING ENGINEERING  
ALIOSKAR GANEM PE.  
LIC. 74745**

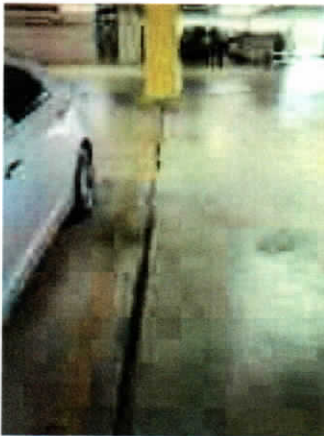
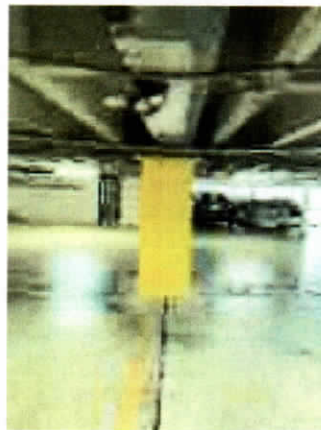
**Type of Repair:** Joint Repair

**Status:** Spalled Concrete y expansion joint to be replaced

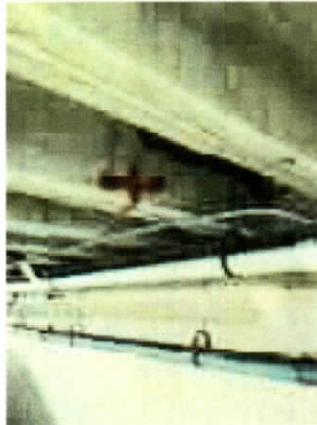
**Type of Repair:** Spalled concrete

**Status:** Spalled Concrete

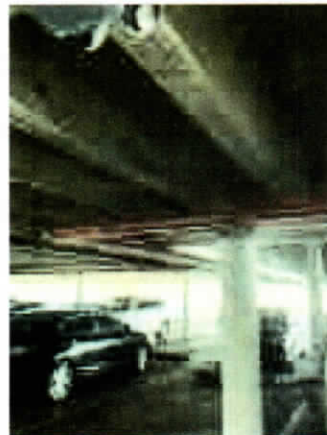
**RP#29**

**Location:** Driveway at 314-315

**Type of Repair:** Spalled concrete

**Status:** Spalled Concrete

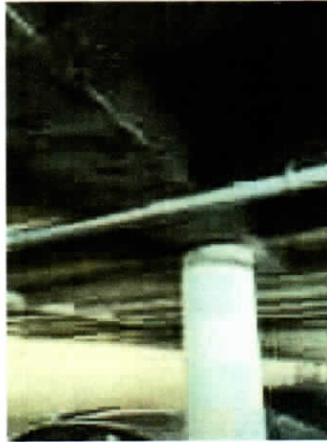
**Type of Repair:** Spalled concrete

**Status:** Spalled Concrete

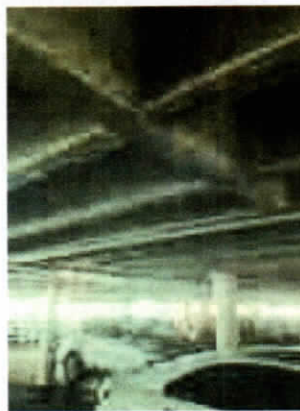
**RP#31**

**Location:** Ground floor parking # 60-61

**Type of Repair:** Honeycombs

**Status:** Spalled Concrete

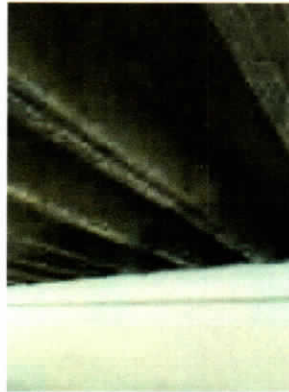
**Type of Repair:** Honeycombs

**Status:** Spalled Concrete

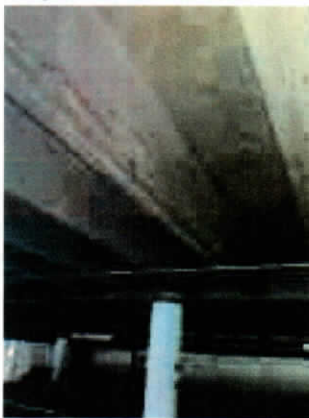
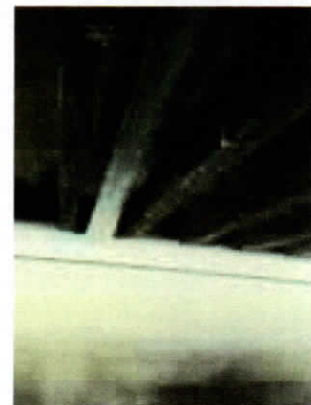
**RP#33**

**Location:** Ground floor, Driveway at parking #59-58 and 53-52

**Type of Repair:** Spalled concrete with rebar exposure

**Status:** Spalled Concrete

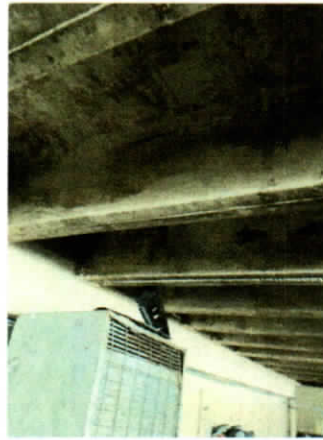
**Type of Repair:** rebars exposure

**Status:** Spalled Concrete

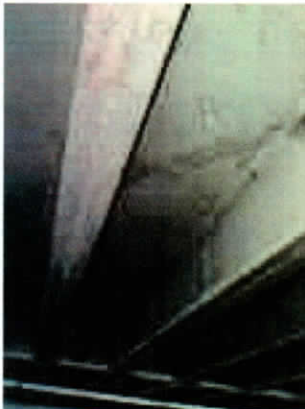
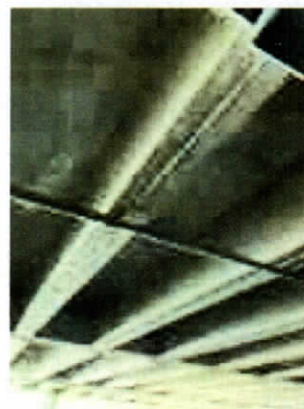
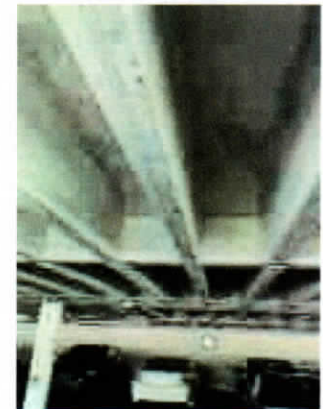
**RP#35**

**Location:** 2<sup>nd</sup> Floor Slab parking # 40-41 and 35-34

**Type of Repair:** crack repair

**Status:** Spalled Concrete

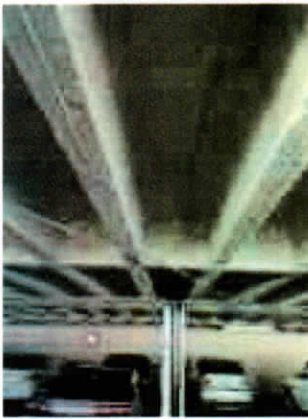
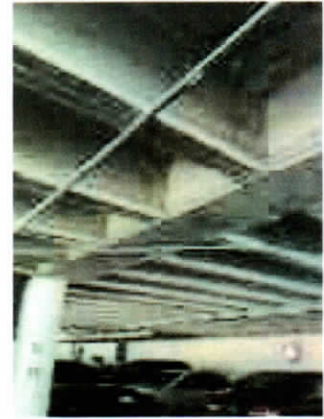
**Type of Reparation:** concrete cracks Repair

**Status:** Spalled Concrete

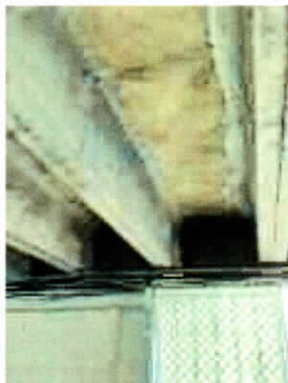
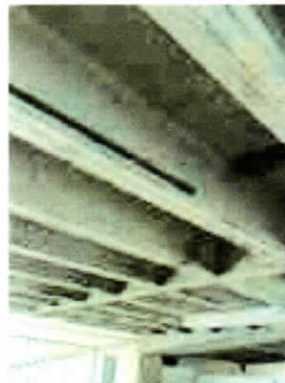
**RP#37**

**Location:** Ground Floor parking # 24-25

**Type of Reparation:** Spalled concrete

**Status:** Spalled Concrete

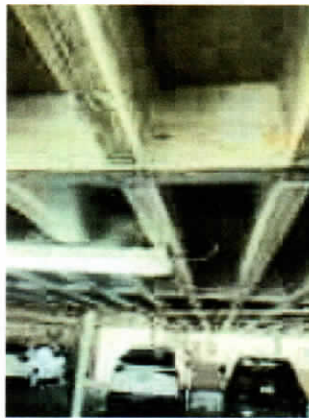
**Type of Repair:** Honeycombs

**Status:** Spalled Concrete

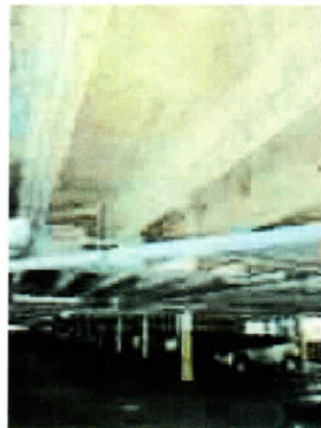
**Type of Reparation:** Full slab repair

**Status:** Spalled Concrete

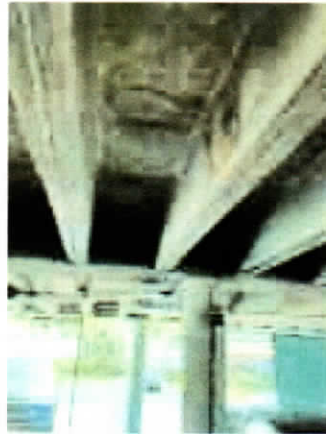
**Type of Repairation:** Spalled concrete

**Status:** Spalled Concrete

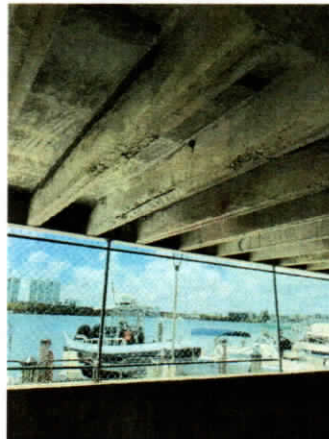
**RP#43**

**Location:** Ground Floor parking # 240

**Type of Repairation:** Spalled concrete

**Status:** Spalled Concrete

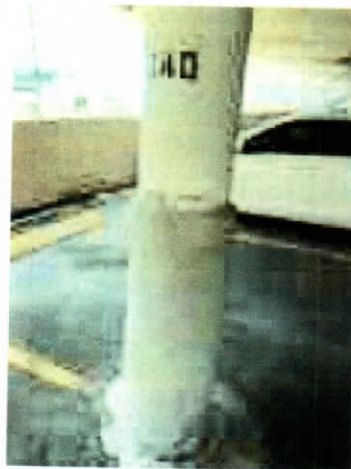
**Type of Repair:** Column repair

**Status:** Finished

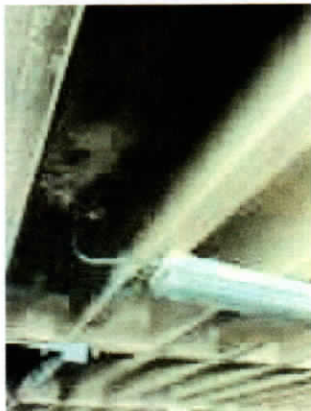
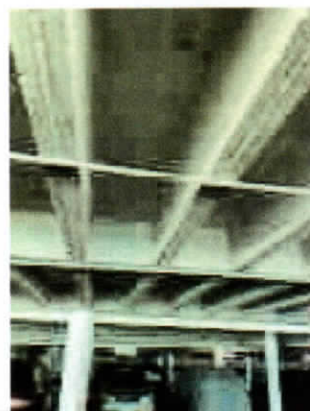
**Type of Reparation:** Spalled Parking

**Status:** Spalled Concrete

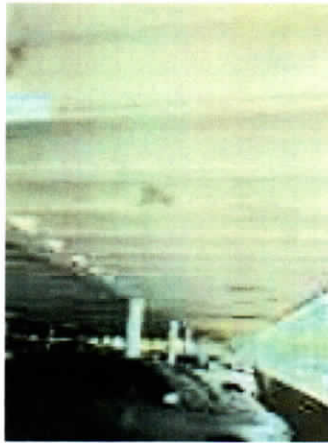
**Type of Repair:** Honeycomb

**Status:** Spalled Concrete

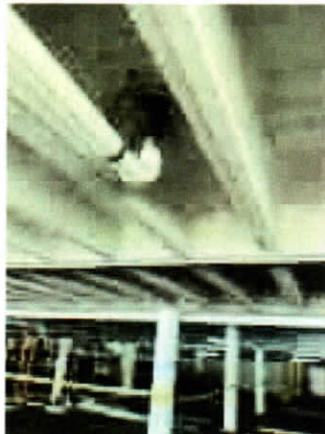
**RP#49**

**Location:** Ground Floor Driveway at parking # 164

**Type of Repair:** Exposed rebar

**Status:** Spalled Concrete

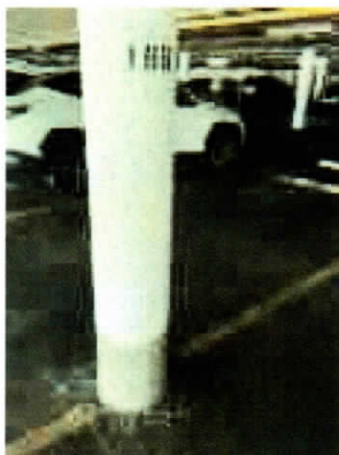
**Type of Repair:** Column repair

**Status:** Finished

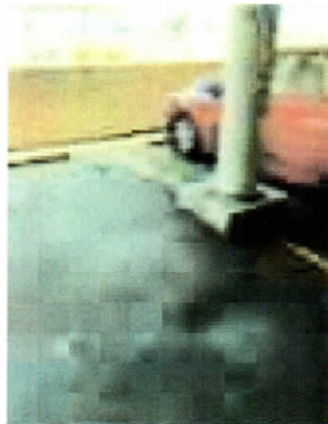
**Type of Repair:** Sunken pavement

**Status:** Inadequate repair

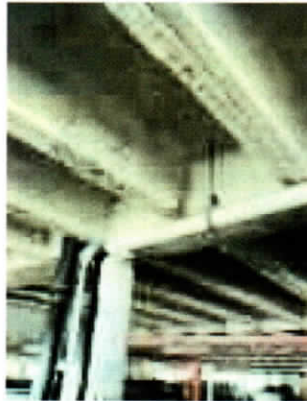
**Type of Repair:** Honeycomb

**Status:** Spalled Concrete

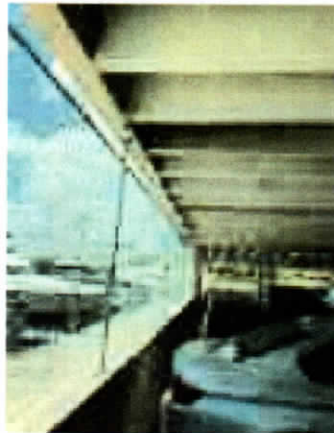
**RP#57**

**Location:** Ground Floor parking # 205

**Type of Repair:** Edge repair

**Status:** Spalled Concrete

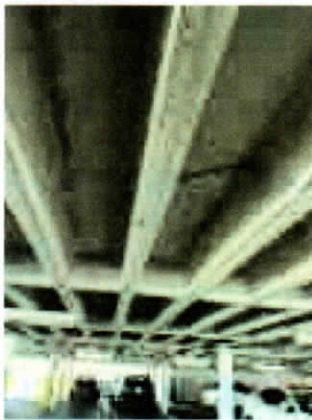
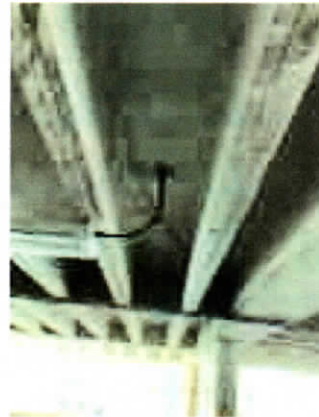
**Type of Repair:** Crack repair

**Status:** Spalled Concrete

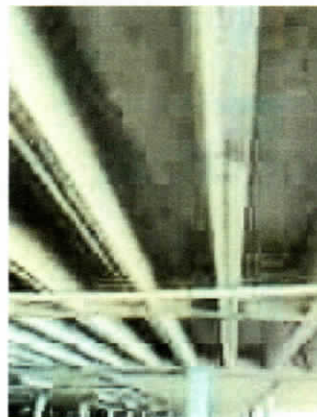
**RP#59**

**Location:** Ground Floor driveway at parking # 126

**Type of Repair:** Crack repair

**Status:** Spalled Concrete

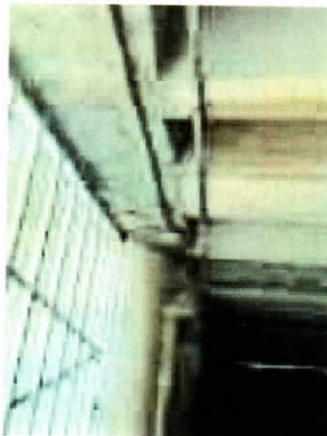
**Type of Repair:** Spalled concrete on beam

**Status:** Spalled Concrete

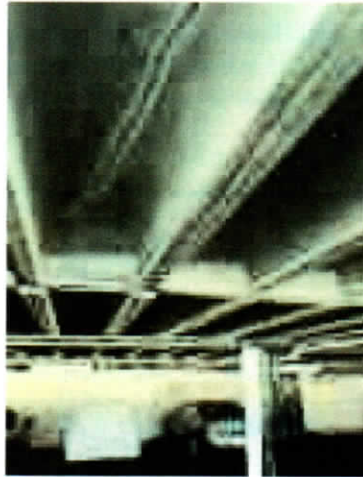
**Status:** Finished

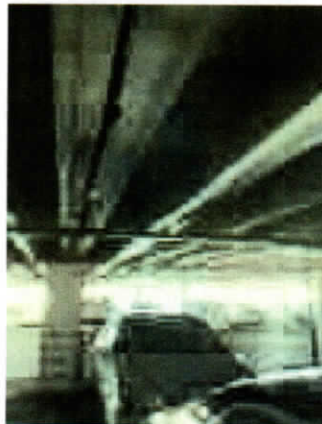
**Type of Repair:** Joint repair

**Status:** Spalled Concrete

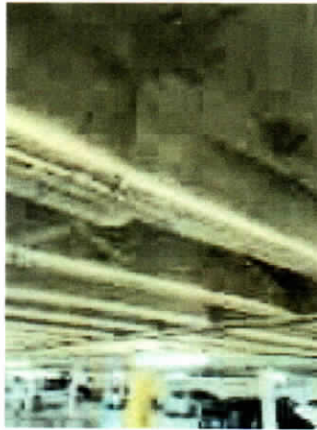
**Type of Reparation:** Crack repair on joist

**Status:** Spalled Concrete

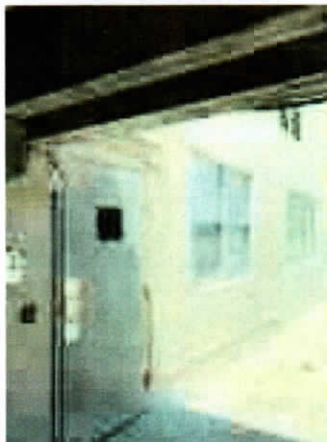
**Type of Reparation:** Edge Repair

**Status:** Spalled Concrete

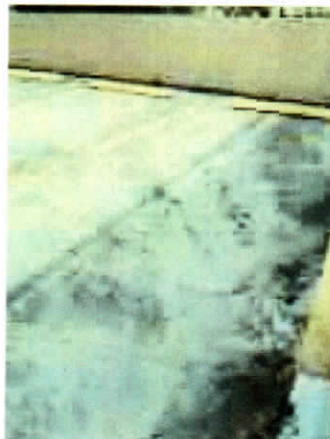
**Type of Reparation:** Crack repair on slab

**Status:** Spalled Concrete

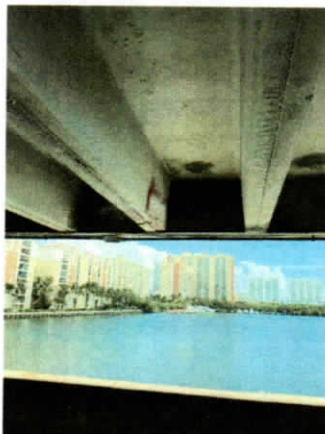
**Type of Reparation:** Spalled concrete and edge repair

**Status:** Spalled Concrete

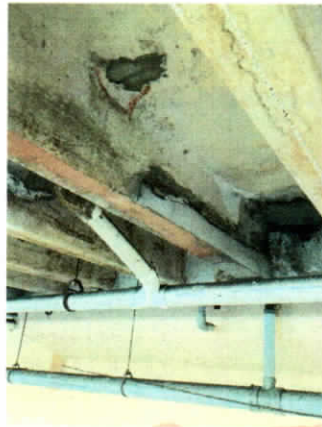
**Type of Repair:** Crack repair on joist

**Status:** Spalled Concrete

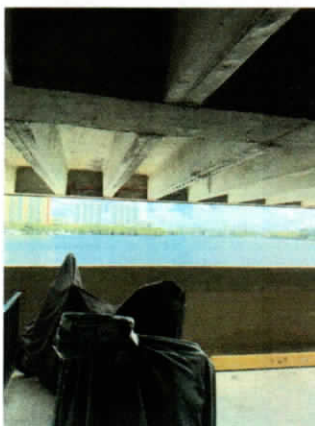
**Type of Repair:** Edge repair

**Status:** Spalled Concrete

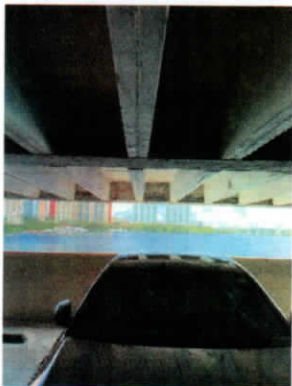
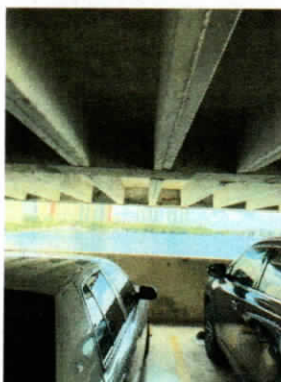
**RP#89**

**Location:** 2<sup>nd</sup> Floor parking # 427, parking #424

**Type of Repair:** Edge repair

**Status:** Spalled Concrete

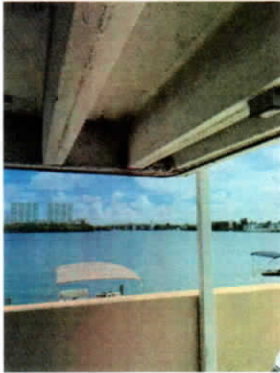
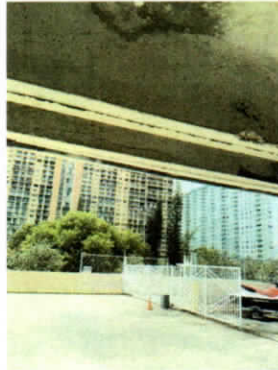
**Type of Repair:** Edge repair

**Status:** Spalled Concrete
